Remediating Sinkholes Beneath the Liner of a Potable Water Lagoon, Alcoa, Tennessee

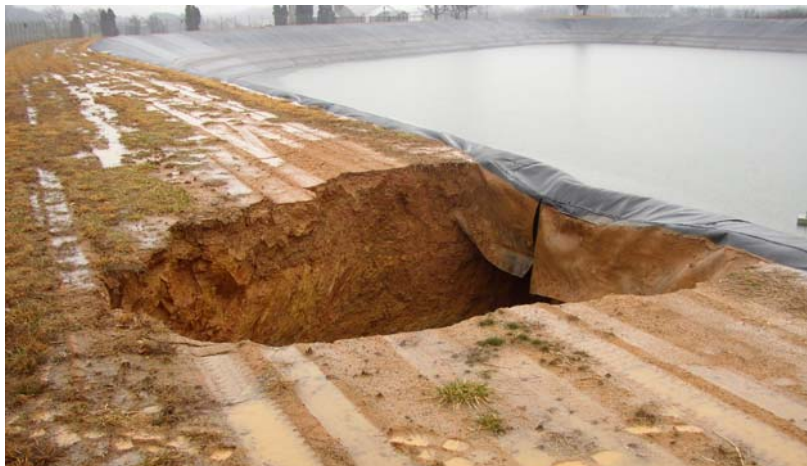
As part of its water treatment process the City of Alcoa, Tennessee, operated a potable water impoundment on a hill above the Little River. During construction in 1991, and again in recent years, the 55 million-gallon-impoundment was compromised by sinkholes. The collapse of sinkholes correlated with discharge from a number of small springs downslope from the impoundment. The flow of five out of seven springs ceased when the impoundment was emptied. Following construction-induced sinkholes, an impermeable liner was installed, and the more recent sinkholes were plugged with low-slump grout, but new sinkholes continued to collapse.

2003 Sinkhole on the berm of the impoundment

The data collected indicate that frequent small karstic drainage paths have developed in the steeply sloping limestone. These small flow paths merge into a network that discharges 1-2 meters above the present river level: dye went to all springs almost simultaneously. A remedial strategy to grout the karstic flow network using a quick-setting high-fluid grout was suggested. The approach is to allow the grout to flow into the discharge network and plug all paths without having adverse effects on the river and groundwater flow from other areas.
